TRANSIT ASSET MANAGEMENT PLAN

Adopted September 24, 2018

Attachment 3.4 Facility Condition Rating Assessment

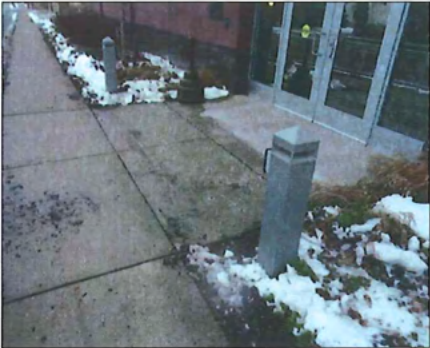
<p style="text-align: center;">No Visible Signs of Cracks</p>
<p>No visible signs of foundation cracks or damage was observed.</p>

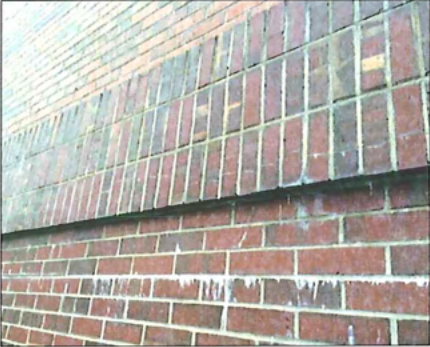
<p style="text-align: center;">Brick Soldier Course</p>
<p>The exterior masonry is in marginal condition. There are issues with the brick soldier course allowing moisture into the wall space. The cast stone roof cap also allows moisture into the wall assembly. These areas should be sealed or refaced with metal panels or new metal wall cap. Visible structural elements appear satisfactory.</p>		
<ul style="list-style-type: none"> Wall Insulation 	3: Adequate

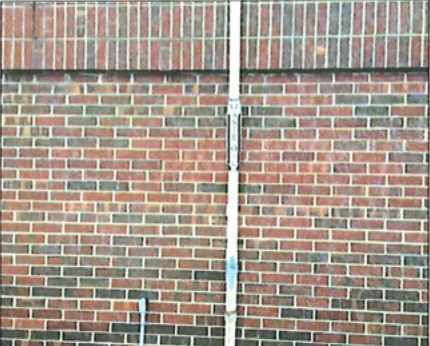
<p style="text-align: center;">Masonry Wall Construction</p>
<p>2010 ASHRAE Standard R-11.4 Continuous Insulation. Original building consists of 8-inch CMU, 1-inch rigid insulation and 4-inch face brick. This assembly has an assumed R-value of 5.55. The 2010 addition exterior walls are constructed with 8-inch concrete block, 2-inch air space and 2-inch rigid insulation with 4-inch face brick. This assembly has an assumed insulation value of R-15 or better.</p>

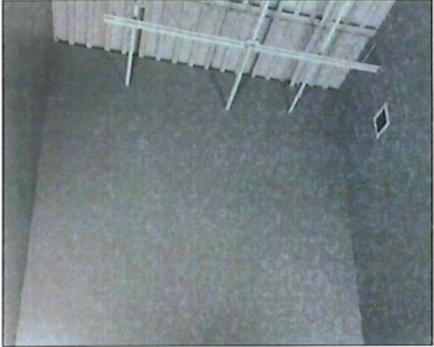
<p style="text-align: center;">Steel Joist and Metal Deck Construction</p>
<p>The original 1977 building structure consists of non-combustible concrete block, concrete columns and concrete roof structure (Type IIA). The 2010 addition consists of concrete block walls, steel columns and steel roof joists.</p>		
<ul style="list-style-type: none"> • Roof: Roof Surface, Gutters, Eaves, Skylights, Chimney Surrounds 	<p>3: Adequate</p>

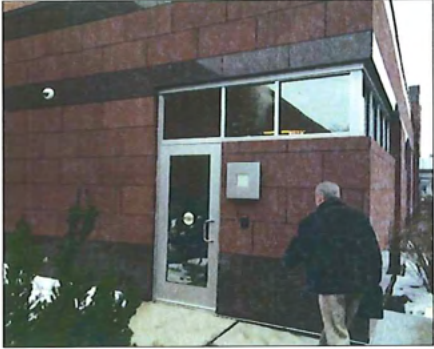
<p style="text-align: center;">Northeast Staff Entry</p>
<p>The 2010 addition was constructed with 1-inch insulated glass. A small number of older windows with original ¼ inch non-insulated glazing remain. 2010 addition exterior doors are aluminum with insulated glass and are satisfactory. A few remaining non-insulated, painted hollow metal doors are in borderline condition.</p>		
<ul style="list-style-type: none"> Openings/Penetrations Are Properly Sealed 	<p>3: Adequate</p>

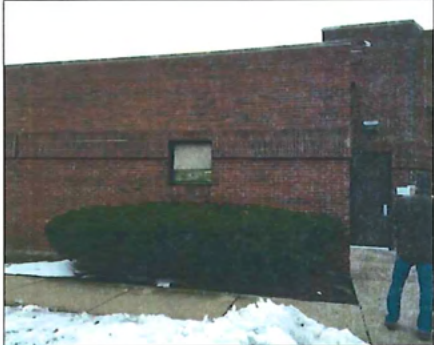
<p style="text-align: center;">West Side Staff Entry</p>
<p>The entry on the northwest corner is visible from the parking lot. The board room entry is not as visible. Public entries have sufficient sheltered canopies. The staff entry on the west side is not sheltered. The staff entry on the northeast side near the picnic table is not sheltered. Entrances and exits are at grade. At areas of sloped walks, handrails are provided.</p>		
<ul style="list-style-type: none"> Daylighting 	<p>3: Adequate</p>

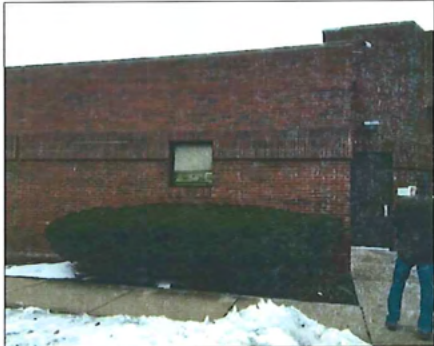
<p style="text-align: center;">Exterior Walls</p>
<p>The overall curb appeal is satisfactory. The 2010 addition is clean and contemporary. The remaining masonry exterior walls are satisfactory.</p>

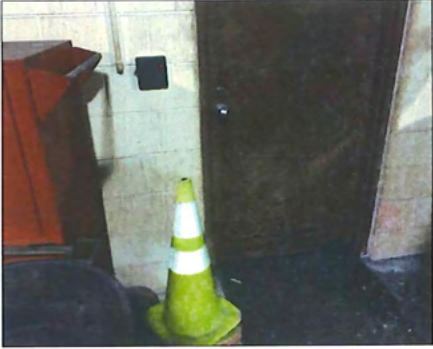
<p style="text-align: center;">Old Door, Knob Type in Hardware</p>
<p>The conditions of walls, doors and hardware is adequate. The 2010 addition is satisfactory. There is evidence of peeling paint & peeling wall covering on walls. The bus service area needs painting. The doors are a mix of new (2010) with proper lever type hardware and old with non-complaint knob type hardware.</p>		
<ul style="list-style-type: none"> Finishes: Materials Used on Walls, Floors and Ceilings 	<p>4: Good</p>

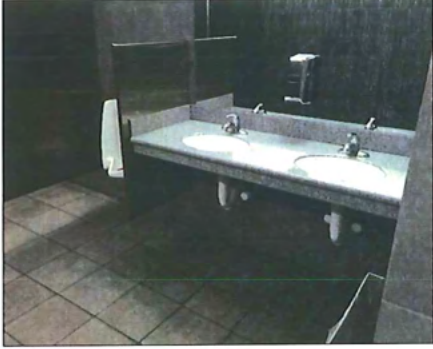
<p style="text-align: center;">Flooring Toilet Rooms</p>
<p>The condition of flooring and ceilings is good. The majority of the office area flooring was replaced in 2010. The flooring is in satisfactory condition. The majority of the office area ceilings were replaced in 2010. The ceilings are in satisfactory condition. The bus service area needs painting.</p>

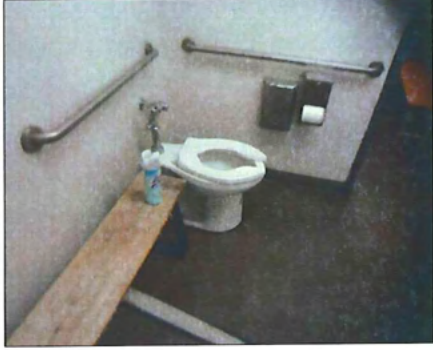
<p style="text-align: center;">Service Tech Toilet Rooms</p>
<p>The addition and drivers lounge toilet rooms were constructed/remodeled in 2010 and are in satisfactory condition. Service technician locker rooms are in borderline condition. Unisex storage area toilet room is in poor condition.</p>

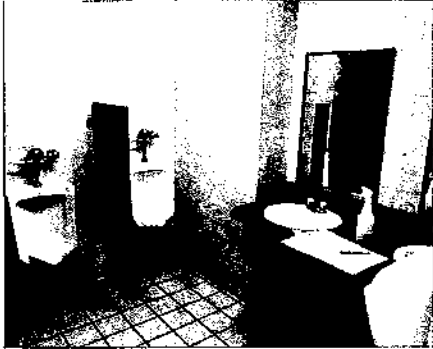
<p style="text-align: center;">Plumbing Fixtures</p>
<p>The condition of plumbing fixtures are adequate for building occupancy.</p>		
<ul style="list-style-type: none"> Barrier Free Toilet Rooms 	4: Good

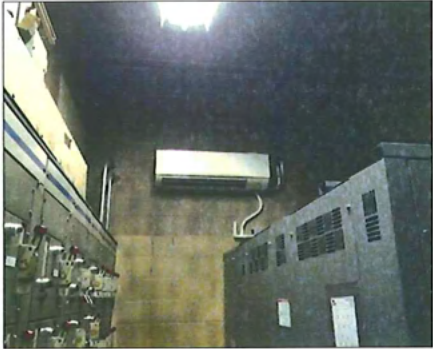
<p style="text-align: center;">Condensate Drain Over Electrical Gear</p>
<p>The condition of the sanitary system is adequate. The condensate drain is directly above electrical gear and should be relocated.</p>		
<ul style="list-style-type: none"> Rain Water Drainage 	<p>4: Good</p>

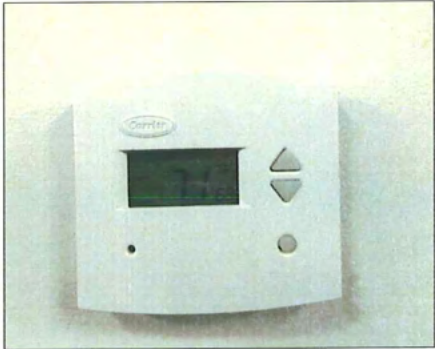
<p style="text-align: center;">Thermostat Controls</p>
<p>The condition of the controls is marginal. The control of the original HVAC equipment in the shop and garage is manual. Temperature control in the office area is inadequate.</p>		
<ul style="list-style-type: none"> Ventilation 	<p>2: Marginal</p>

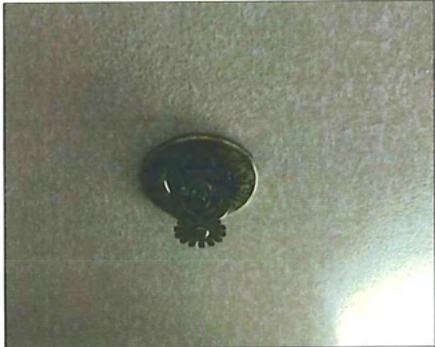
<p style="text-align: center;">Building is Fully Sprinkled</p>
<p>A fire sprinkler system is installed throughout the building.</p>		
<ul style="list-style-type: none"> • Fire Alarm 	<p>2: Marginal</p>

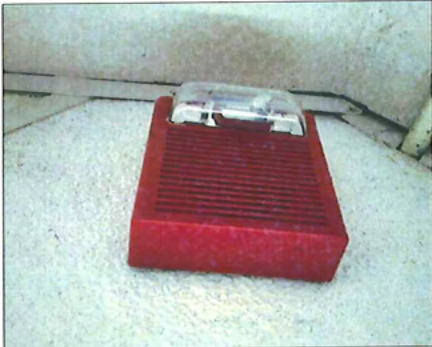
<p style="text-align: center;">Wall Device</p>
<p>Fire alarm system is out of date in some areas, some spaces have all mounted strobes attached to ceiling, coverage could be examined.</p>

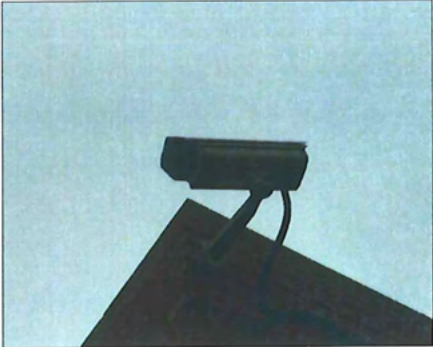
<p>Security Camera</p> </div>
<p>Security control is provided at entry points. Overhead door entry is not secure. Suggest access to be added to overhead doors with vehicles tags.</p>		
<ul style="list-style-type: none"> • Card Access 	4: Good	NEED A PHOTO
<p>EPS monitored access system is installed</p>		
<ul style="list-style-type: none"> • Egress Stairways 	5: Excellent	NEED A PHOTO
<p>Exit stairways (mezzanine levels) is code compliant.</p>

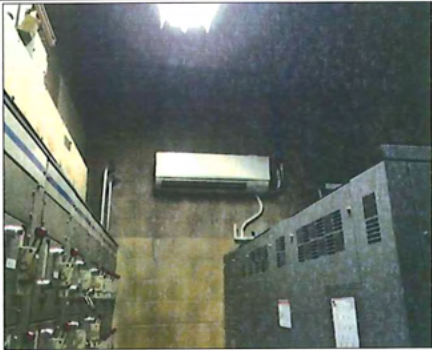
<p style="text-align: center;">Electrical Service</p>		
<table border="1" style="width: 100%;"> <tr> <td style="width: 30%; vertical-align: top;"> <ul style="list-style-type: none"> • Condition of Electrical Service </td> <td style="vertical-align: top;"> <p>5: Excellent</p> </td> </tr> </table> <p>Facility substation consists of a new Square D 750 kVA 8320/480 dry type transformer serving a new main distribution panel, 1200A main with metering.</p>	<ul style="list-style-type: none"> • Condition of Electrical Service 	<p>5: Excellent</p>

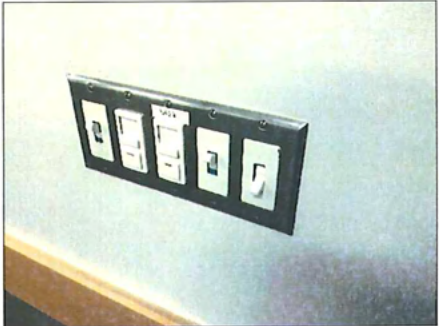
<p style="text-align: center;">Lighting Controls</p>
<p>Some newly added or renovated spaces are provided with occupancy sensors to meet energy code. There are many areas (older office and other storage rooms, etc.) that have no automatic lighting control.</p>		
<ul style="list-style-type: none"> • Condition of Receptacles and Circuiting 	<p>3: Adequate</p>

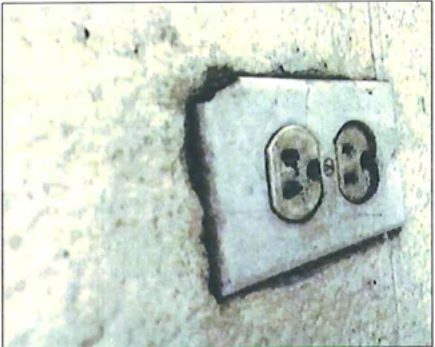
<p style="text-align: center;">Old Receptacle</p>
<p>There are worn and aging receptacles in areas that would be replaced in a renovation. Receptacles appear to meet code and should be replaced in the older parts of the building.</p>		
<ul style="list-style-type: none"> • Communications & Security 	<p>3: Adequate</p>

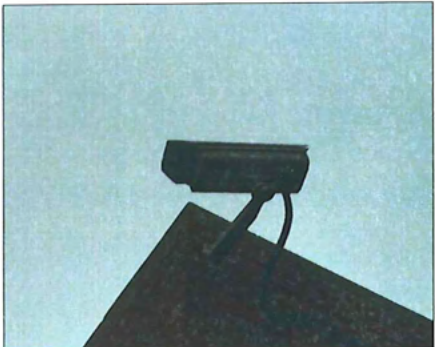
<p style="text-align: center;">Security Camera</p>
<p>A security camera system is installed. The camera and recording system is outdated. An update is recommended to IP WDR cameras</p>

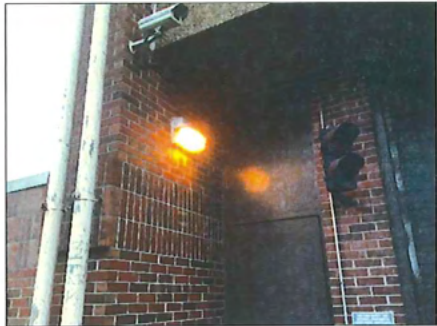
<p style="text-align: center;">Security Lighting</p>
<p>Emergency lighting is provided and meets current egress requirements. Emergency lighting is provided with double head emergency battery packs. Any renovation would incorporate emergency into the normal light.</p>

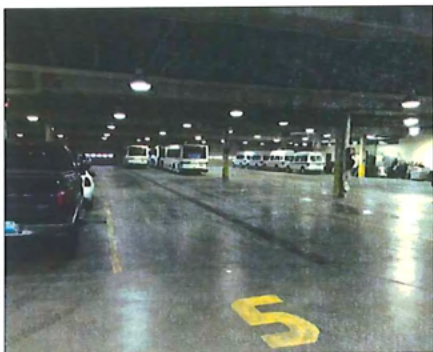
<p style="text-align: center;">Bus Storage</p>
<p>The roadways and driveways as well as associated signage, markings and equipment are satisfactory.</p>

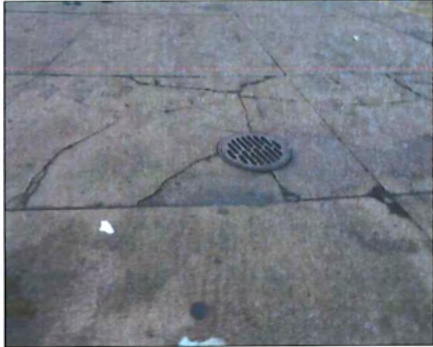
<p style="text-align: center;">Concrete Paving is Cracked</p>
<p>Vehicle concrete has cracks across large areas, but pavement is not spalling. Asphalt parking lot has cracking and some large settling cracks.</p>		
<ul style="list-style-type: none"> • On Site Parking 	<p>3: Adequate</p>

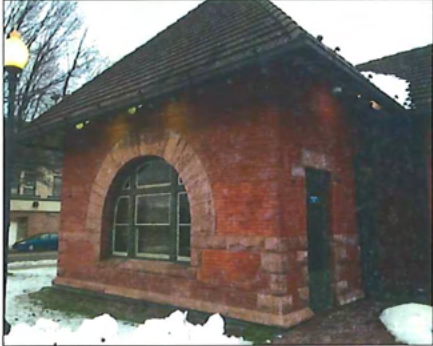
Condition of the Visible Foundation
Condition of the visible foundations is satisfactory.		
<ul style="list-style-type: none"> Basement 	3: Adequate

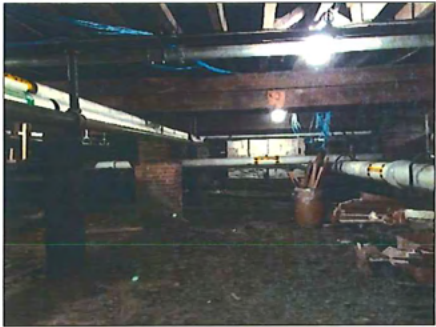
Basement
The basement area is congested and dirty. Some areas of the floor slab need to be replaced.		
B. Shell	TERM Rating	Photos
<ul style="list-style-type: none"> Superstructure / Structural Frame Including Columns, Pillars, and Walls 	4: Good

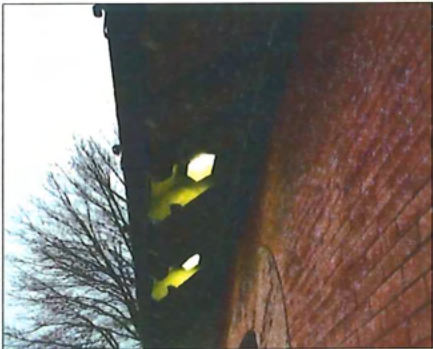
Wood Framed Roof
The roof framing appears to be satisfactory. There is a section of the first-floor wood framing that needs to be replaced in the basement area.		
<ul style="list-style-type: none"> Wall Insulation 	3: Adequate

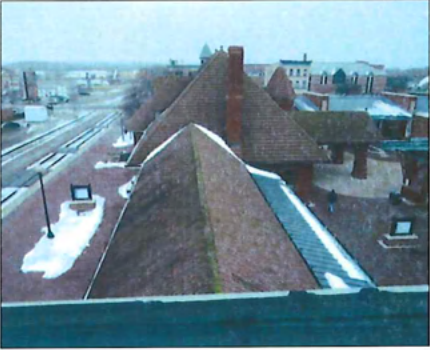
<p style="text-align: center;">Discoloration on Slate Roof</p>
<p>Good slate roof restored in 1987. There is evidence of some discoloration and staining that should be cleaned. The bus canopy has a metal panel roof system. The existing snow guards need to be replaced. There is some rubber roof membrane installed in 2006 that is in good condition.</p>

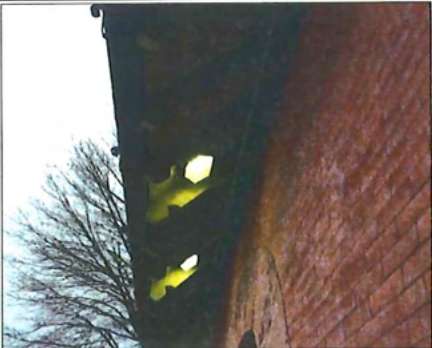
<p style="text-align: center;">Wood Framed Roof</p>
<ul style="list-style-type: none"> Exterior: Windows, Doors, and All Finishes (paint, masonry) 	<p style="text-align: center;">4: Good</p>
<p>The exterior masonry and stone is in satisfactory condition. There are some areas that need to be cleaned. The existing wood overhangs and soffits require continual maintenance and painting.</p>

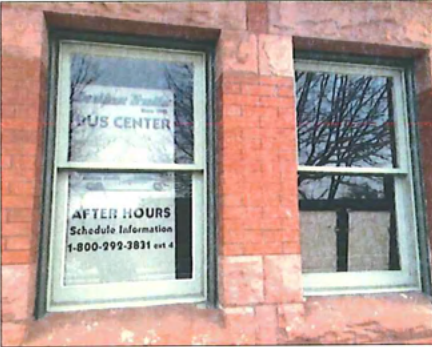
<p style="text-align: center;">Exterior Masonry</p>
<ul style="list-style-type: none"> Openings/Penetrations Are Properly Sealed 	<p style="text-align: center;">5: Excellent</p>
<p>No major openings, holes or penetrations were visible in the building envelope.</p>

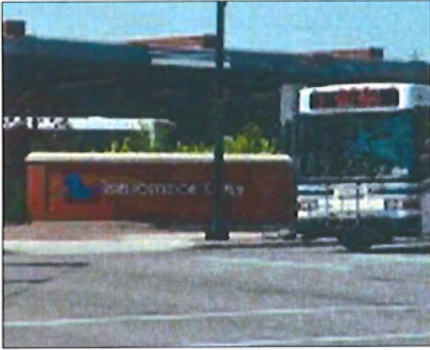
<p style="text-align: center;">Site Signage</p>	
<p>“Welcome to Kalamazoo” sign, track side seems a little celebratory. Directional signage is adequate. Transportation Center monument signs at each corner need new letters and lighting.</p>		<ul style="list-style-type: none"> • Building Entrances <p>The entrances have good coverage over the bus area. The train station has good coverage at the main entries. There is no cover “track side”-passengers can stay inside.</p>

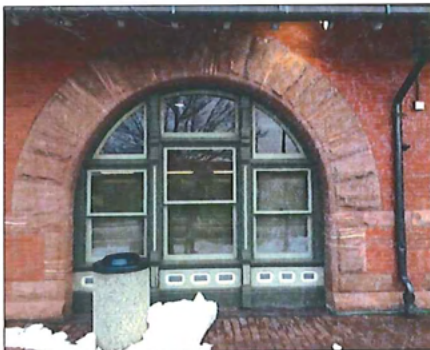
<p style="text-align: center;">Large Windows for Natural Daylighting</p>	
<p>The building has large windows on the north and south sides with an abundance of daylighting.</p>

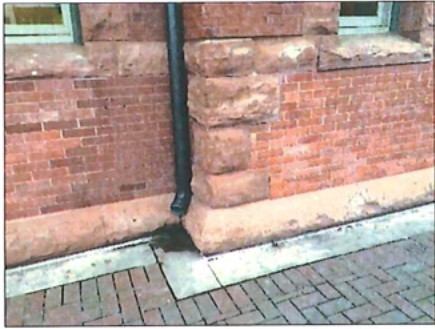
<p style="text-align: center;">Downspout on Transportation Center</p>
<p>The gutters and downspouts are in good shape however the downspouts create ponding on the walkways.</p>		
<ul style="list-style-type: none"> • Overall Curb Appeal 	<p>5: Excellent</p>

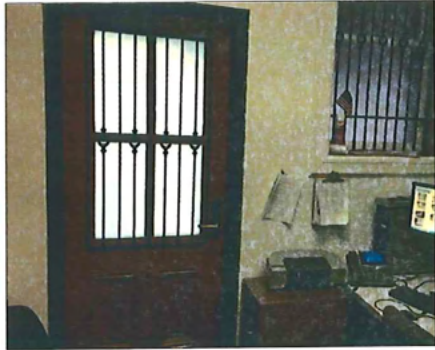
<p style="text-align: center;">Wood Doors</p>
<p>The walls are in satisfactory condition. The restored fire places are excellent. The wood paneling is excellent. The wood doors are in satisfactory condition. The hardware is the proper lever type.</p>

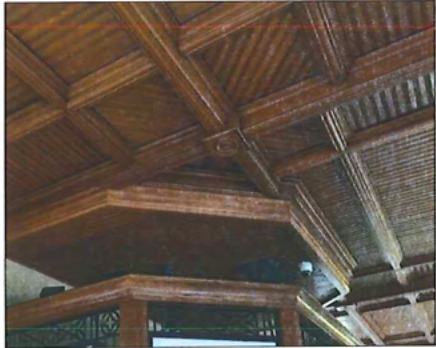
<p style="text-align: center;">Wood Ceiling</p>
<p>The ceilings were restored/remodeled in 2006 and are in satisfactory condition. The wood ceiling in the waiting area is beautiful. The flooring was restored/remodeled in 2006 and is in satisfactory condition. The restored terrazzo flooring is satisfactory.</p>		
<p>D. Plumbing</p>	<p>TERM Rating</p>	<p>Photos</p>
<ul style="list-style-type: none"> • Condition of Toilet Rooms 	<p>4: Good</p>

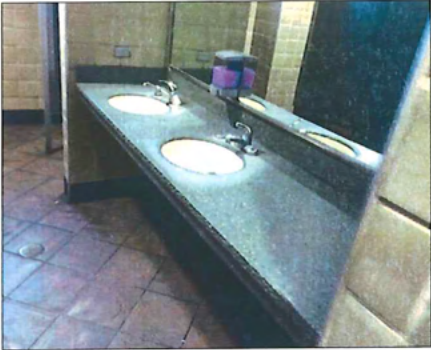
<p style="text-align: center;">Toilet Rooms</p>
<p>Toilet rooms were remodeled in 2006 and are in satisfactory condition. There are some signs of damage due to vandalism on the toilet partitions.</p>

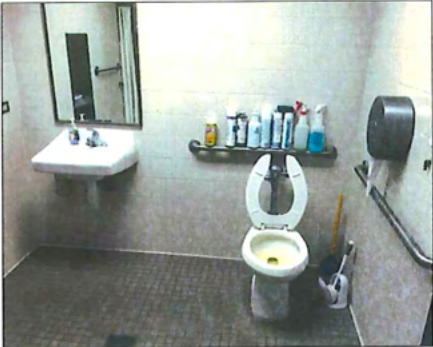
<p style="text-align: center;">Plumbing Fixtures</p>
<p>The plumbing fixtures are adequate for building occupancy. The sanitary line is undersized. Consider replacing the sanitary line during the next major renovation.</p>		
<ul style="list-style-type: none"> • Barrier Free Toilet Rooms 	<p>4: Good</p>

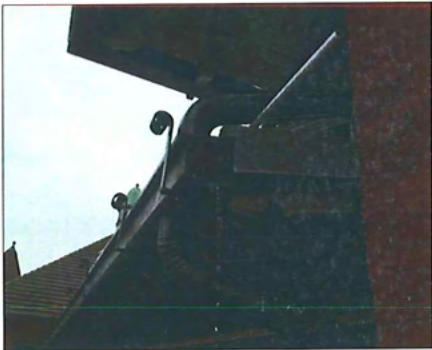
<p style="text-align: center;">Gutter and Downspouts</p>
<p>Downspouts create nuisance puddles in the pedestrian traffic area.</p>		
<p>E. HVAC</p>	<p>TERM Rating</p>	<p>Photos</p>
<ul style="list-style-type: none"> Energy Supply 	<p>2: Marginal</p>

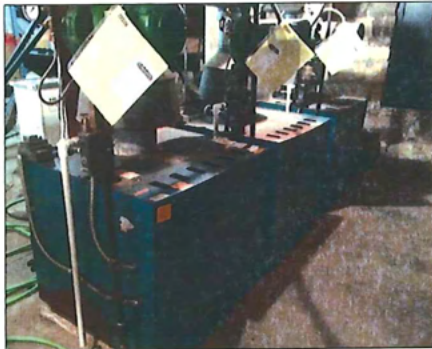
<p style="text-align: center;">Aged Heating Boilers</p>
<p>The boilers are aged. Poor gas pressure and flow rate. Cannot run all three boilers at one time.</p>

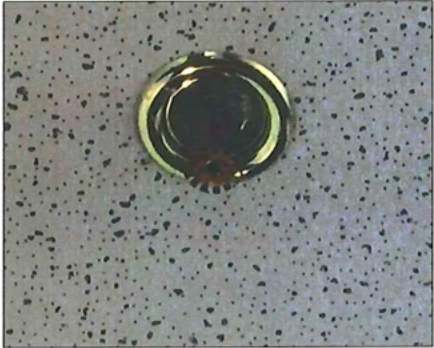
<p style="text-align: center;">Sprinklers</p>
<p>The building is fully sprinkled.</p>		
<ul style="list-style-type: none"> Fire Alarm 	4: Good

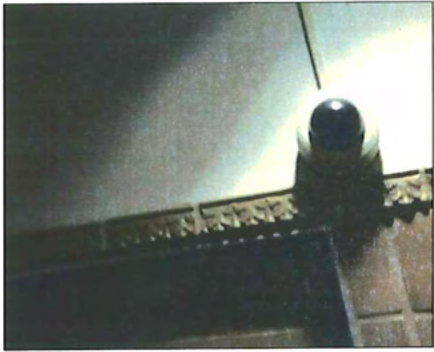
<p style="text-align: center;">Security Camera</p>
<p>There is a system in place but it is outdated. Recommend an update to IP using wide dynamic range cameras and network recording device.</p>

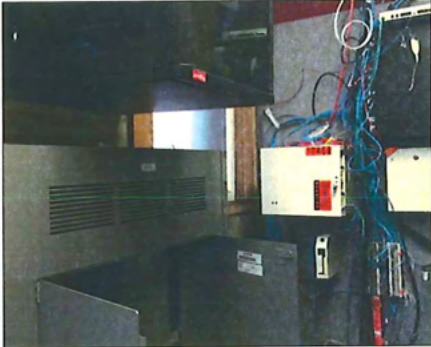
<p style="text-align: center;">Electrical Service</p>
<p>The distribution and branch panels are in great condition. There were a couple of panels that were not updated that could use replacement.</p>		
<ul style="list-style-type: none"> Condition of Electrical Service 	5: Excellent

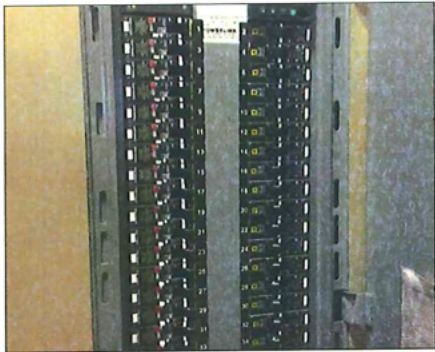
<p style="text-align: center;">Electrical Panel</p>
<p>The electrical was renovated in the 2004-2006 renovation. The service is fed from a Consumers pad mount transformer serving a 1200A 208V main panel. The panel is equipped with metering and surge protection.</p>

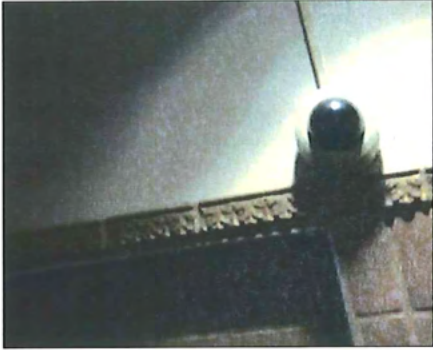
<p style="text-align: center;">Security Camera</p>
<p>The facility is a public building. Access points are not secured. They can be monitored by staff. Suggest account control be added to the storage area.</p>		
<ul style="list-style-type: none"> Other Electrical System-Related Pieces Such As Lightning Protection, Generators, and Emergency Power 	<p>4: Good</p>

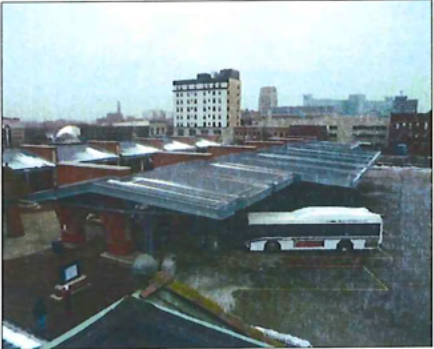
<p style="text-align: center;">Site</p>
<p>The site is very small and there is lots of activity taking place in one location. No room for growth.</p>
