TRANSIT ASSET MANAGEMENT PLAN

Adopted September 24, 2018

Attachment 3.4 Facility Condition Rating Assessment

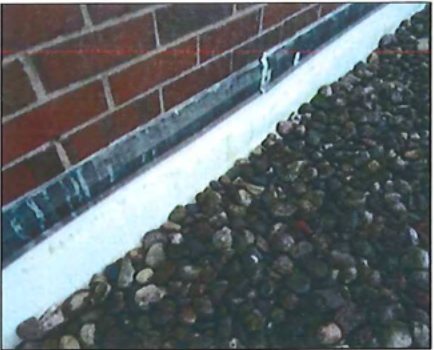
<p style="text-align: center;">Ballasted Membrane Roof</p>
<p>The original building area roof is stone ballasted membrane installed in 2002 with an assumed warranty period of 25 years (expiring in 2027). The 2010 addition is a membrane roof with an assumed warranty period of 20 years (expiring in 2030).</p>		
<ul style="list-style-type: none"> • Roof Insulation 	<p>5: Excellent</p>

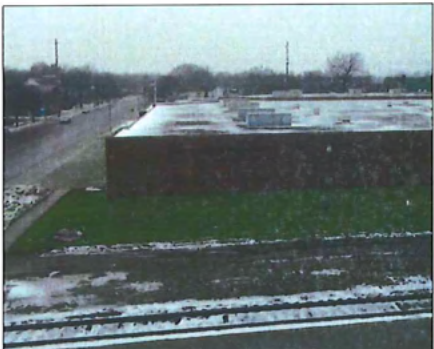
<p style="text-align: center;">Roof of Bus Storage/Service/Administration</p>

<p>2010 ASHRAE Standard requires an R-20 value. The addition in 2010 and re-roof in 2002 is assumed to have a minimum of 4 inches of rigid insulation.</p>

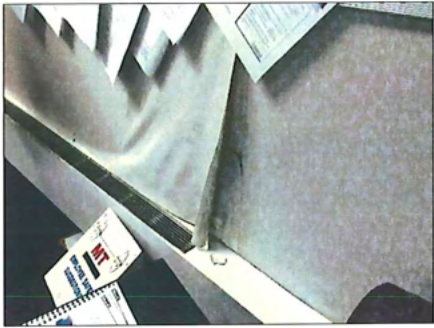
<p style="text-align: center;">Peeling Wallpaper</p>
<p>No major openings, holes or penetrations were visible in the building envelope. Peeling paint and wallpaper are a good indication there is evidence of water infiltration in the wall assembly. See superstructure.</p>		
<ul style="list-style-type: none"> Exterior Building and Site Signage 	<p>4: Good</p>

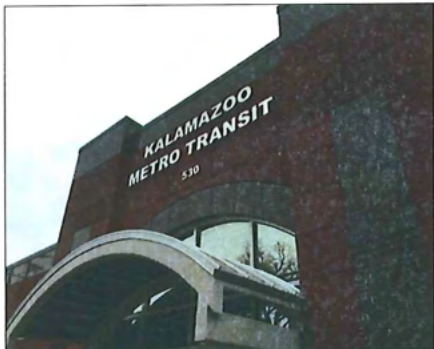
<p style="text-align: center;">Front Signage</p>

<p>The building signage is provided on the north side, northwest and southwest corners. No signage is located on the east side of the building.</p>

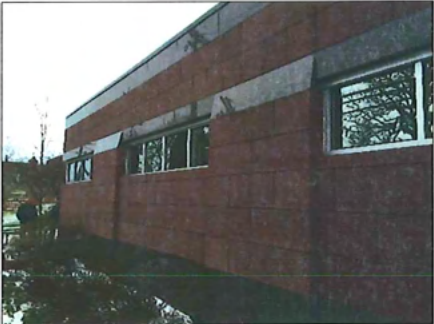
<p style="text-align: center;">Exterior Windows</p>
<p>Original building has poor daylighting. The 2010 addition has large windows, skylights with good daylighting.</p>		
<ul style="list-style-type: none"> Overall Curb Appeal 	<p>4: Good</p>

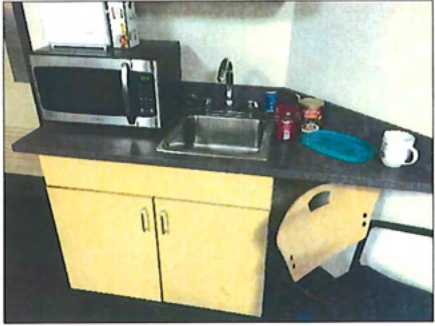
<p style="text-align: center;">Kitchen Area</p>
<p>Staff break room was added in 2010 and is in satisfactory condition. Drivers lounge area is in borderline condition.</p>		
<ul style="list-style-type: none"> • Condition of Casework 	<p>4: Good</p>

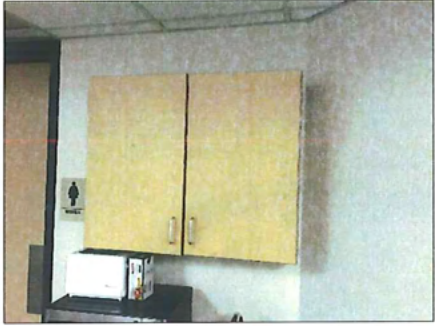
<p style="text-align: center;">Casework</p>
<p>Building in casework appear to be satisfactory.</p>		
<ul style="list-style-type: none"> • Condition of Visual Displays 	<p>4: Good</p>

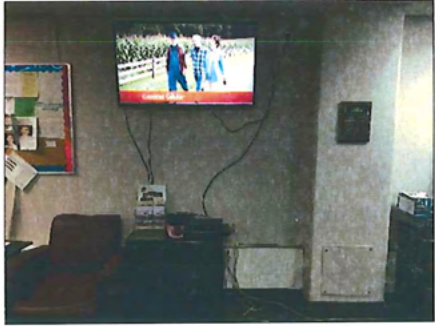
<p style="text-align: center;">Television</p>
<p>Visual display boards, employee notice areas, tack boards and TV monitors appear satisfactory.</p>		
<ul style="list-style-type: none"> • Condition of Lockers 	<p>4: Good</p>

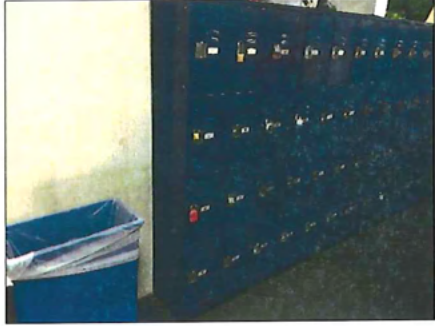
<p style="text-align: center;">Staff Lockers</p>
<p>Lockers appear to be satisfactory</p>

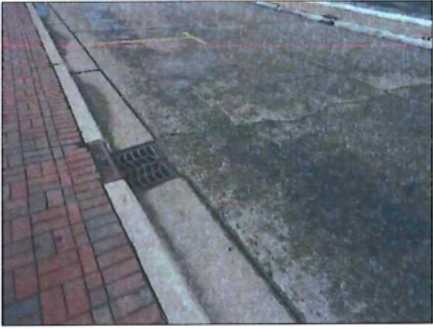
<p style="text-align: center;">Rain Water Drainage</p>
<p>The condition of storm system is good. There were no issues raised or identified.</p>		
<p>E. HVAC</p>	<p>TERM Rating</p>	<p>Photos</p>
<ul style="list-style-type: none"> Energy Supply 	<p>4: Good</p>

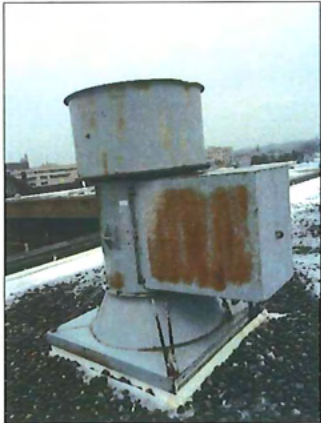
<p style="text-align: center;">Air Handling Equipment</p>
<p>The makeup air units and original exhaust fan have served their useful life and should be considered for replacement within 5 years.</p>		
<ul style="list-style-type: none"> Testing, Balancing, Controls and Instrumentation 	<p>2: Marginal</p>

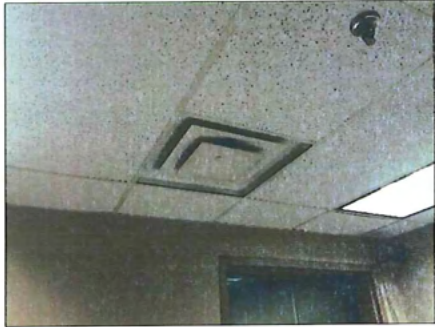
<p style="text-align: center;">Exhaust Fan</p>
<p>The indoor air quality in both the shop and garage is very poor. Select toilet room exhaust fans are not working. Ducts are dirty as evident from dust spots on the ceiling.</p>

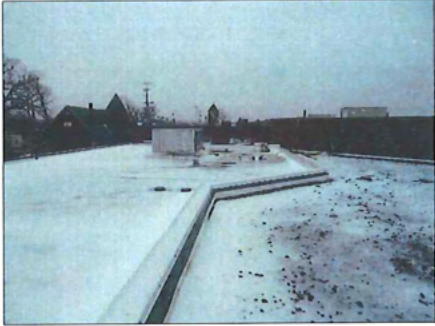
<p style="text-align: center;">Roof of Administrative Building</p>
<p>There are some plumbing vent stacks and HVAC vents which are in satisfactory condition.</p>		
<p>F. Fire Protection/Life Safety</p>	<p>TERM Rating</p>	<p>Photos</p>
<ul style="list-style-type: none"> • Sprinklers 	<p>5: Excellent</p>

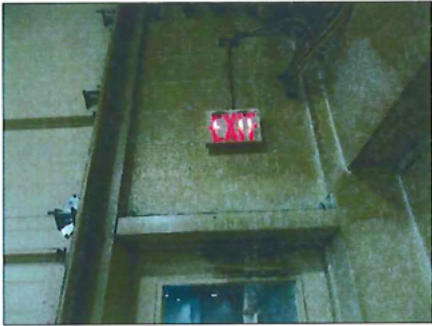
<p style="text-align: center;">Exit Door</p>
<p>Exit doors open outward and are provided with panic type hardware. Exiting is code compliant. Corridor egress routes are code compliant.</p>		
<ul style="list-style-type: none"> • Hydrants and Other Fire Protection Specialties 	3: Adequate

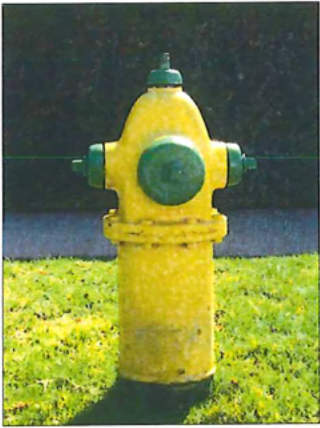
<p style="text-align: center;">Fire Hydrant</p>
<p>The hydrants and other fire protection is satisfactory. The building is on the City of Kalamazoo water supply with adequate hydrant locations.</p>		
G. Electrical	TERM Rating	Photos
<ul style="list-style-type: none"> • Electrical Service & Distribution 	3: Adequate

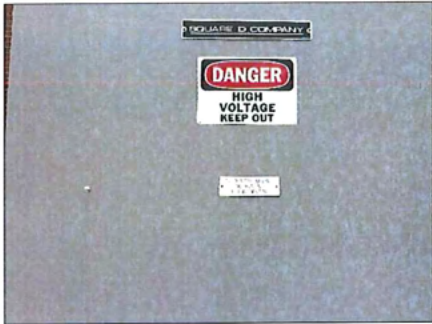
<p style="text-align: center;">Electrical Service</p>		
<table border="1" style="width: 100%;"> <tr> <td style="width: 30%; vertical-align: top;"> <ul style="list-style-type: none"> • Condition of Electrical Service </td> <td style="vertical-align: top;"> <p>5: Excellent</p> </td> </tr> </table> <p>Facility substation consists of a new Square D 750 kVA 8320/480 dry type transformer serving a new main distribution panel, 1200A main with metering.</p>	<ul style="list-style-type: none"> • Condition of Electrical Service 	<p>5: Excellent</p>

<p style="text-align: center;">Square D Transformer</p>
<ul style="list-style-type: none"> • Condition of Electrical Service 	<p>5: Excellent</p>

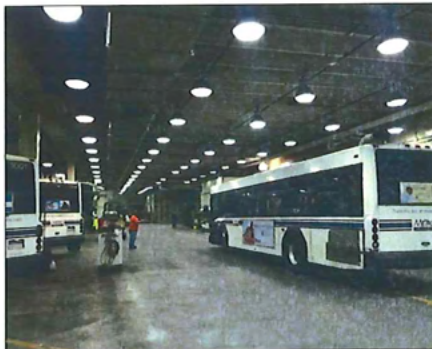
<table border="1" style="width: 100%;"> <tr> <td style="width: 30%; vertical-align: top;"> <ul style="list-style-type: none"> • Lighting & Branch Wiring (Interior and Exterior) </td> <td style="vertical-align: top;"> <p>3: Adequate</p> </td> </tr> </table> <p>Lighting is primarily metal halide in the garage and workshop areas, mixture of different linear fluorescent and compact fluorescent in the office areas. Can be improved in aesthetics and energy utilization with LED fixtures.</p>	<ul style="list-style-type: none"> • Lighting & Branch Wiring (Interior and Exterior) 	<p>3: Adequate</p>

<p style="text-align: center;">Metal Halide Lighting</p>
<ul style="list-style-type: none"> • Lighting & Branch Wiring (Interior and Exterior) 	<p>3: Adequate</p>

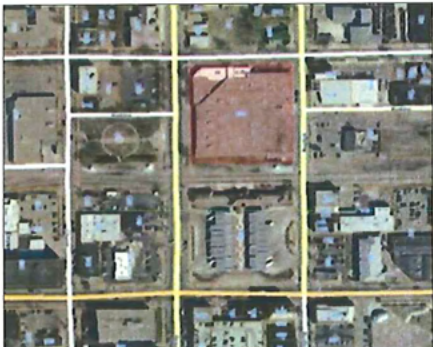
<p style="text-align: center;">Site Aerial</p>
<p>There is minimum area for expansion. The site is maximized. The site is stable with no signs of erosion. The site drains to the city streets. The street curb and gutters have areas of surface water ponding.</p>		
<ul style="list-style-type: none"> Roadways/Driveways and Associated Signage, Markings, and Equipment 	<p>3: Adequate</p>

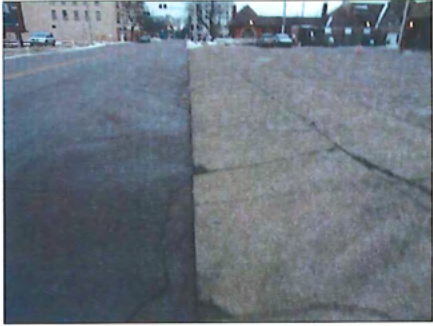
<p style="text-align: center;">Entrance/Exit</p>
<p>The majority of the facility traffic is designed to pull through. There is minimal backup.</p>		
<ul style="list-style-type: none"> • Parking Lots and Associated Signage, Markings, and Equipment 	<p>3: Adequate</p>

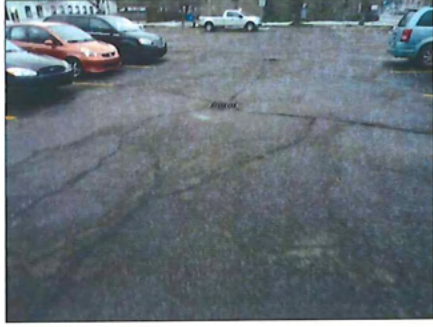
<p style="text-align: center;">Parking Lot Across the Street</p>
<p>There is an approximate 50 car parking lot across the street that does not provide sufficient parking. Minimal parking adjacent to the building. Bollards are needed to protect the building.</p>

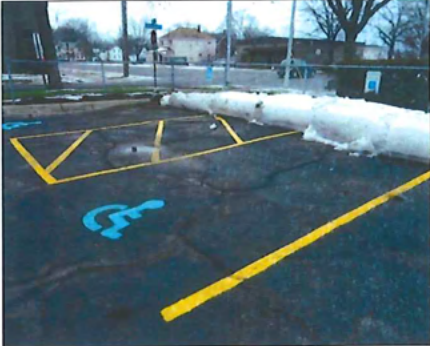
<p>Barrier free is provided in the lot across the street. There are two accessible spaces of 49 non-accessible spaces provided. No barrier free parking is adjacent to the building. Accessible walks are excellent.</p>

<p style="text-align: center;">Barrier Free Parking</p>	
<ul style="list-style-type: none"> • Pedestrian Areas and Associated Signage, Markings, and Equipment 	<p style="text-align: center;">3: Adequate</p>

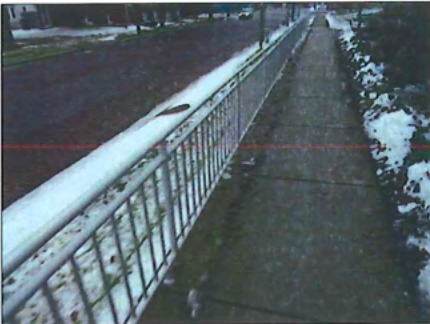
<p style="text-align: center;">Pedestrian Sidewalk</p>
<p>Paved surfaces include adequate sidewalks with crosswalks, curb cuts, etc. City streets contain cross walks at intersections. The west parking lot does not have a dedicated cross walk to the building entry. The separation of bus, car and pedestrian traffic is adequate for the safety of the occupants.</p>		
<ul style="list-style-type: none"> • Site Development Such as Fences, Walls, and Miscellaneous Structures 	<p style="text-align: center;">3: Adequate</p>

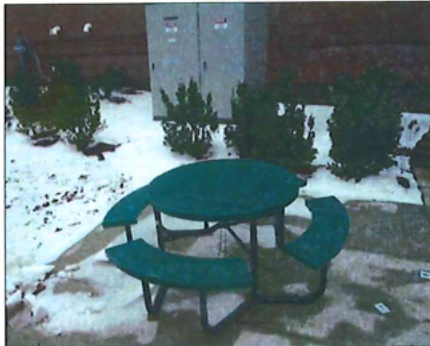
<p style="text-align: center;">Picnic Table Area</p>

<p>Outdoor facilities are adequate. Picnic table area appears to be satisfactory.</p>		
<ul style="list-style-type: none"> • Landscaping and Irrigation 	<p style="text-align: center;">4: Good</p>

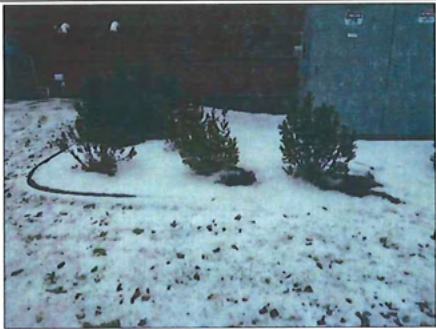
<p>Landscaping is irrigated and appears to be well maintained.</p>

<p style="text-align: center;">Landscaping</p>
<ul style="list-style-type: none"> • Site Utilities 	<p>3: Adequate</p>
<p>Water, sanitary and sewer is provided by the City of Kalamazoo. Natural gas distribution is provided by Consumers.</p>

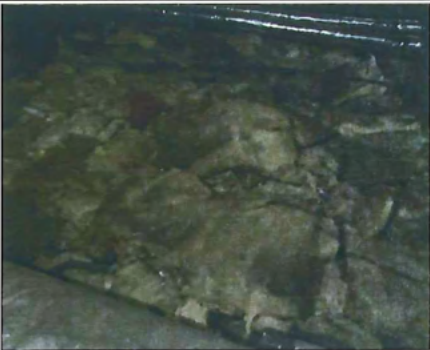
<p style="text-align: center;">Insulation in Attic</p>
<ul style="list-style-type: none"> Structure Combustibility 	<p>3: Adequate</p>

<p>2010 ASHRAE Standard R-11.4. Continuous insulation. Original building consists of interior drywall, metal studs (assumed batt insulation) 8-inch masonry and 4-inch face brick. This assembly has an assumed R-value of R-8.</p>

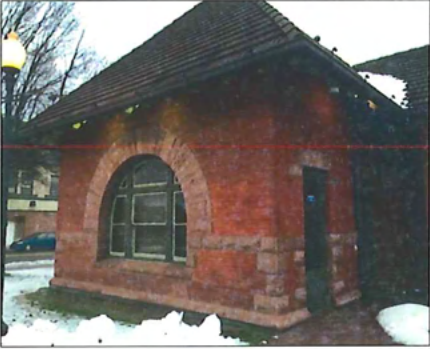
<p style="text-align: center;">Exterior Masonry and Stone Bearing Walls</p>
<p>The structure is wood framed roof and floor construction with masonry exterior bearing walls.</p>		
<ul style="list-style-type: none"> Roof: Roof Surface, Gutters, Eaves, Skylights, Chimney Surrounds 	<p>4: Good</p>

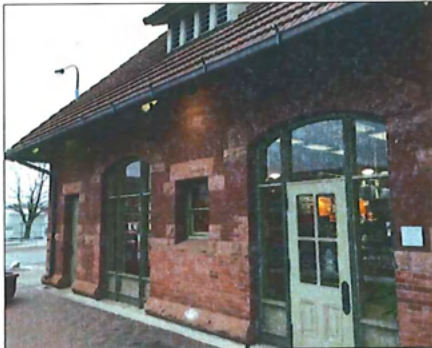
<p style="text-align: center;">Building Envelope</p>

<p style="text-align: center;">Exterior Masonry</p>
<ul style="list-style-type: none"> Openings/Penetrations Are Properly Sealed 	<p style="text-align: center;">5: Excellent</p>
<p>No major openings, holes or penetrations were visible in the building envelope.</p>

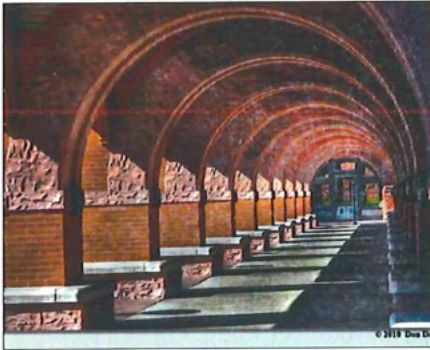
<p style="text-align: center;">Coverage Over Bus Area</p>
<ul style="list-style-type: none"> • Daylighting 	10: Excellent

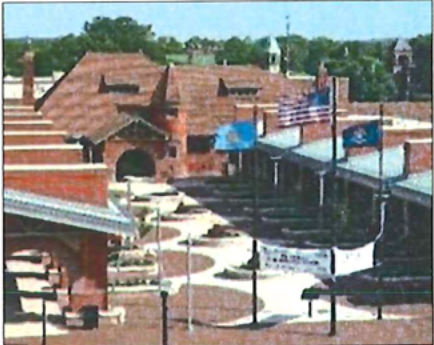
<p style="text-align: center;">Beautiful Facility</p>
<p>It is beautiful, iconic, historic facility.</p>		
<p>C. Interiors</p>	<p>TERM Rating</p>	<p>Photos</p>
<ul style="list-style-type: none"> • Partitions: Walls, Interior Doors, Fittings, Signage 	<p>5: Excellent</p>

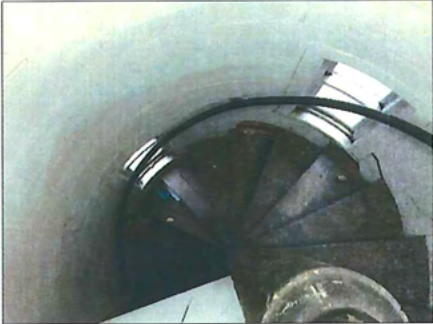
<p style="text-align: center;">Basement Stairs</p>
<p>The stairs are for basement and attic access for mechanical purposes only.</p>		
<ul style="list-style-type: none"> • Finishes: Materials Used on Walls, Floors and Ceilings 	<p>4: Good</p>

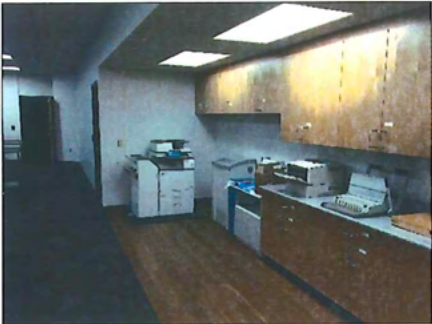
<p style="text-align: center;">Kitchen Area</p>
<p>The kitchen area in the café contains 3-compartment sink for cleaning and disinfecting. The area is in satisfactory condition.</p>		
<ul style="list-style-type: none"> • Condition of Casework 	4: Good

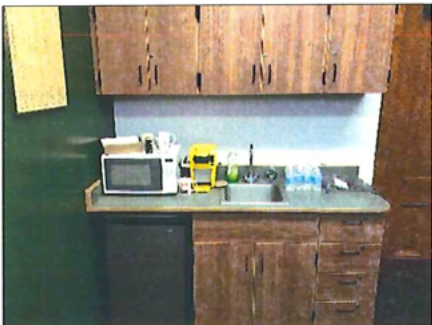
<p style="text-align: center;">Casework and Countertops</p>
<p>The casework, countertops and other built in items are satisfactory.</p>		
<ul style="list-style-type: none"> • Condition of Visual Displays 	5: Excellent

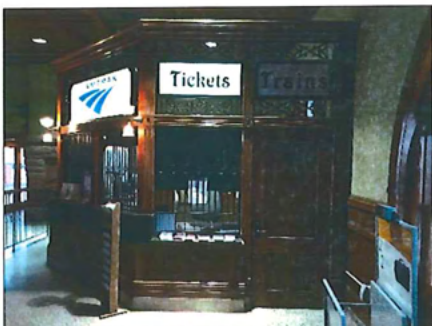
<p style="text-align: center;">Visual Displays</p>
<p>The visual displays, room signage, way finding signage is excellent.</p>

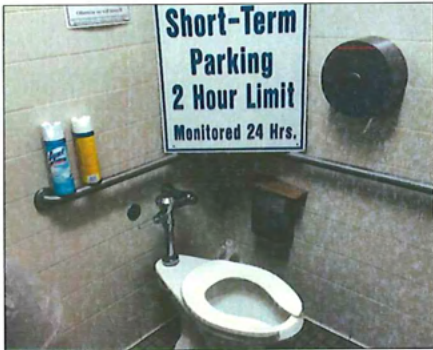
<p style="text-align: center;">Accessible Toilets</p>
<p>The toilet rooms are accessible. The toilet stalls do not contain a vertical grab bar (requirement add in 2012 Michigan Building Code adopted 9/1/2014).</p>		
<ul style="list-style-type: none"> • Water Distribution 	<p>4: Good</p>

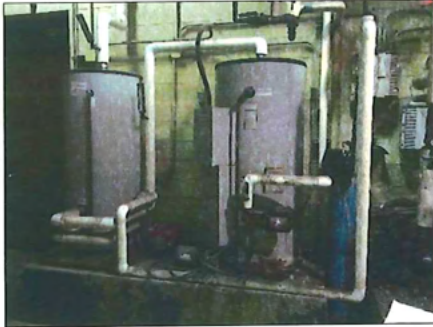
<p style="text-align: center;">Water Distribution</p>
<p>The condition of the internal water distribution is satisfactory. No issues raised or identified.</p>

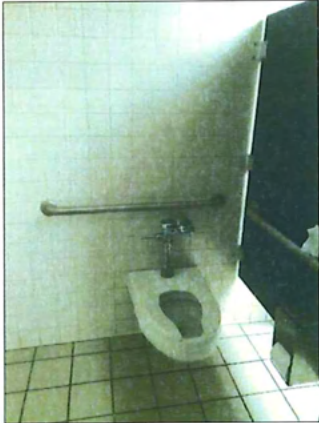
<p style="text-align: center;">Public Toilet Room</p>
<p>The condition of the sanitary waste is satisfactory. No issues raised or identified.</p>		
<ul style="list-style-type: none"> Rain Water Drainage 	<p>2: Marginal</p>

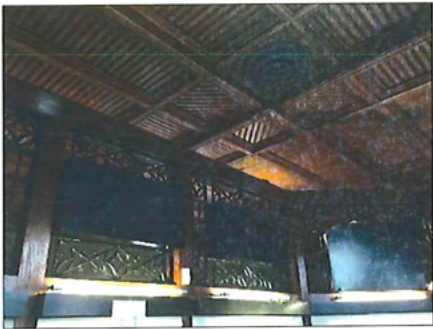
<p style="text-align: center;">Ventilation</p>
<p>Poor ventilation and air distribution in main toilet rooms.</p>		
<ul style="list-style-type: none"> Chimney and Vents 	4: Good

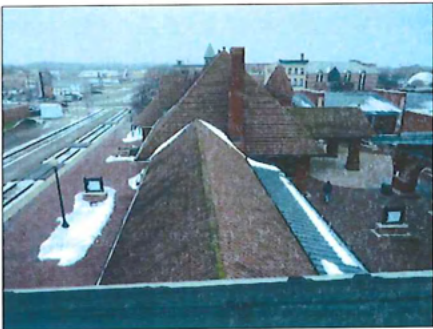
<p style="text-align: center;">Chimney</p>
<p>There are some plumbing vent stacks and HVAC vents which are in satisfactory condition.</p>

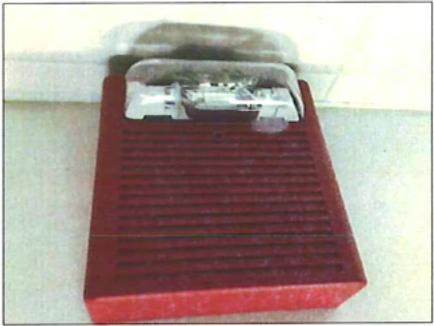
<p style="text-align: center;">Fire Alarm</p>
<p>Noticed a few power supplies that need to be on dedicated circuits.</p>		
<ul style="list-style-type: none"> Security Access 	2: Marginal

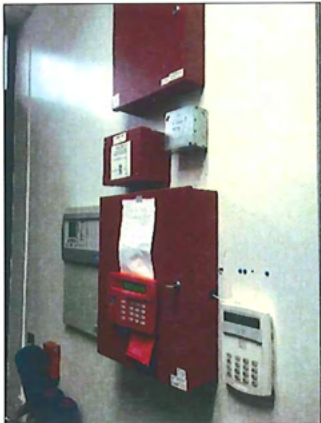
<p>Security Panel</p> </div>
<p>A card access is provided. Office areas, Consumer's service, Amtrak area and the concessions area are accessed by manual key.</p>		
<ul style="list-style-type: none"> • Egress Stairway 	<p>10: Excellent</p>	<div style="text-align: center;">

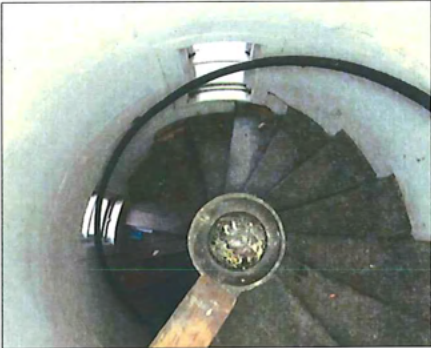
<p>Spiral Stair For Mechanical Room</p> </div>
<p>Egress stairway from the mechanical attic is compliant.</p>		
<ul style="list-style-type: none"> • Exit Door 	<p>5: Excellent</p>	<div style="text-align: center;">

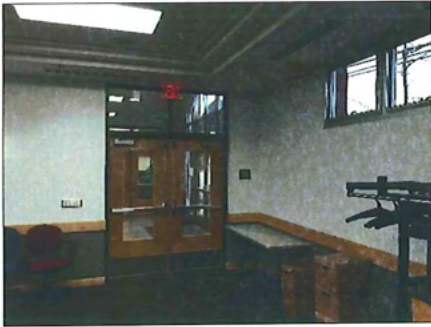
<p>Exit Door</p> </div>
<p>Exit doors are code compliant.</p>

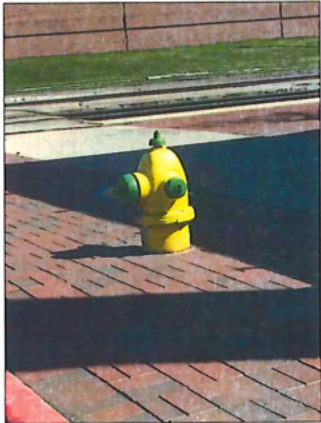
<p style="text-align: center;">Fire Hydrant</p>
<p>The hydrants and other fire protection is satisfactory. The building is on the City of Kalamazoo water supply with adequate hydrant locations.</p>

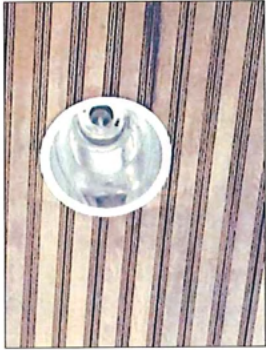
<p style="text-align: center;">Lights in Main Lobby</p>
<p>Lighting was renovated in 2005 with the building renovation. The light fixtures are not the most energy efficient to today's standards, however, they have appropriate historic aesthetic. Emergency lighting is provided and meets current egress requirements.</p>		
<ul style="list-style-type: none"> • Lighting Controls Meet Energy Code 	<p>3: Adequate</p>

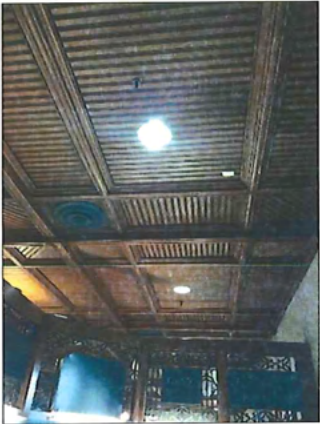
<p style="text-align: center;">Interior Lighting</p>
<p>The time of day / photo controls are utilized for the exterior lighting, interior spaces are provided with some sensors, although not all areas are controlled as required by code.</p>		
<ul style="list-style-type: none"> • Condition of Receptacles and Circuiting 	<p>5: Excellent</p>

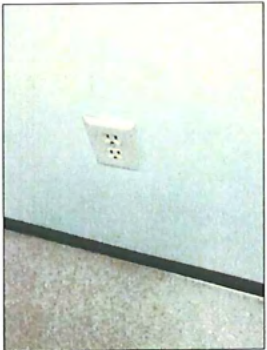
<p style="text-align: center;">Receptacle</p>

<p>The receptacles were generally replaced in the building renovation and are in good condition.</p>

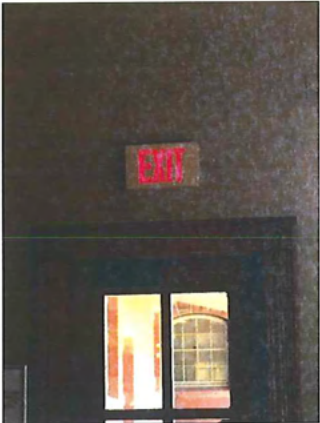
<p style="text-align: center;">Exit Sign</p>
<p>This building does not have an emergency generator system supplying backup power.</p>		
<p>H. Site</p>	<p>TERM Rating</p>	<p>Photos</p>
<ul style="list-style-type: none"> General Site 	<p>2: Marginal</p>

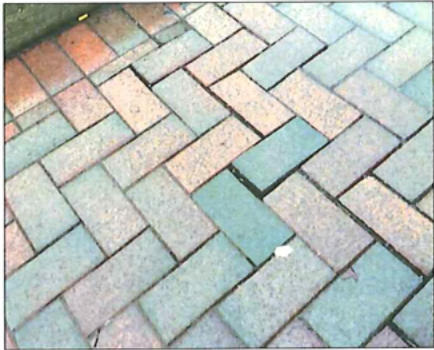
<p style="text-align: center;">Uneven Brick Pavers</p>
<p>Some minor cracks in vehicle concrete. Some minor un even brick pavers.</p>		
<ul style="list-style-type: none"> • Vehicular Entrances and Exits 	<p>3: Adequate</p>

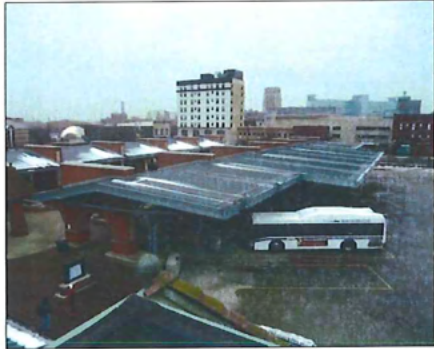
<p style="text-align: center;">Site</p>
<p>The busses back out of the loading parking spaces. The bus entrance is very near the intersection at Kalamazoo Ave.</p>		
<ul style="list-style-type: none"> • Parking Lots and Associated Signage, Markings, and Equipment 	<p>4: Good</p>

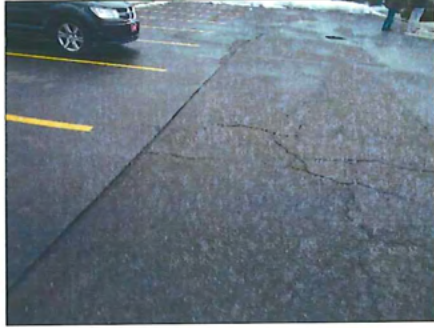
<p style="text-align: center;">Parking Across the Street</p>
<p>No onsite parking is available. There are two loops for drop-off and pick-up only. Parking is available across the street, at meters or at other City locations. Parking lots has cracking is asphalt.</p>

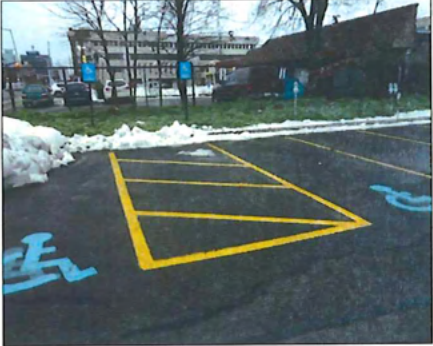
<p style="text-align: center;">Barrier Free Parking</p>
<p>Barrier Free spaces provided in parking is provided along the curb and the lot across Rose Street but there isn't a direct cross walk. Pedestrians have to walk to Kalamazoo Avenue intersection to cross.</p>		
<ul style="list-style-type: none"> • Pedestrian Areas and Associated Signage, Markings, and Equipment 	<p>4: Good</p>

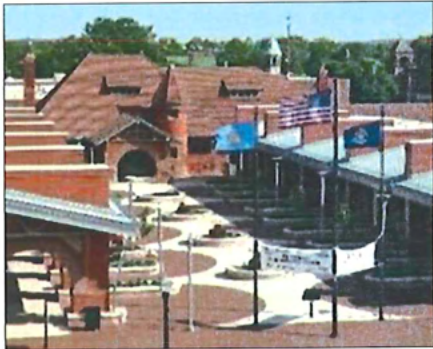
<p style="text-align: center;">Entry Plaza</p>
<p>No striped crosswalk to parking area across Park Street. City curb cuts are satisfactory.</p>		
<ul style="list-style-type: none"> • Site Development Such as Fences, Walls, and Miscellaneous Structures 	<p>5: Excellent</p>

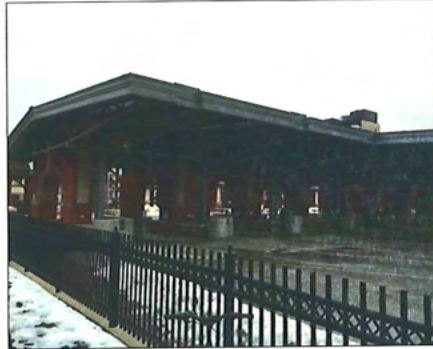
<p style="text-align: center;">Fence Along Bus Canopy</p>
<p>The plaza area between the bus loading is open and attractive complete with benches for sitting and gathering.</p>

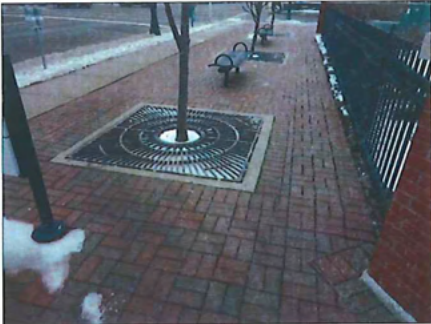
<p style="text-align: center;">Areas of Landscaping</p>
<p>Landscaping is irrigated and appears to be well maintained.</p>		
<ul style="list-style-type: none"> • Site Utilities 	<p>3: Adequate</p>

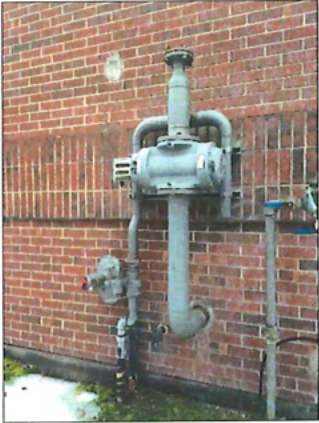
<p style="text-align: center;">Gas Service</p>
<p>Water, sanitary and sewer is provided by the City of Kalamazoo. Natural gas distribution is provided by Consumers.</p>
